Amherstview West Secondary Plan Phase One Environmental Site Assessment

Amherstview West Secondary Plan Phase One Environmental Assessment

PROJECT NO.: 211-01353-00

Subject: Phase One Environmental Site Assessment – Amherstview West Secondary Plan, Amherstview, ON

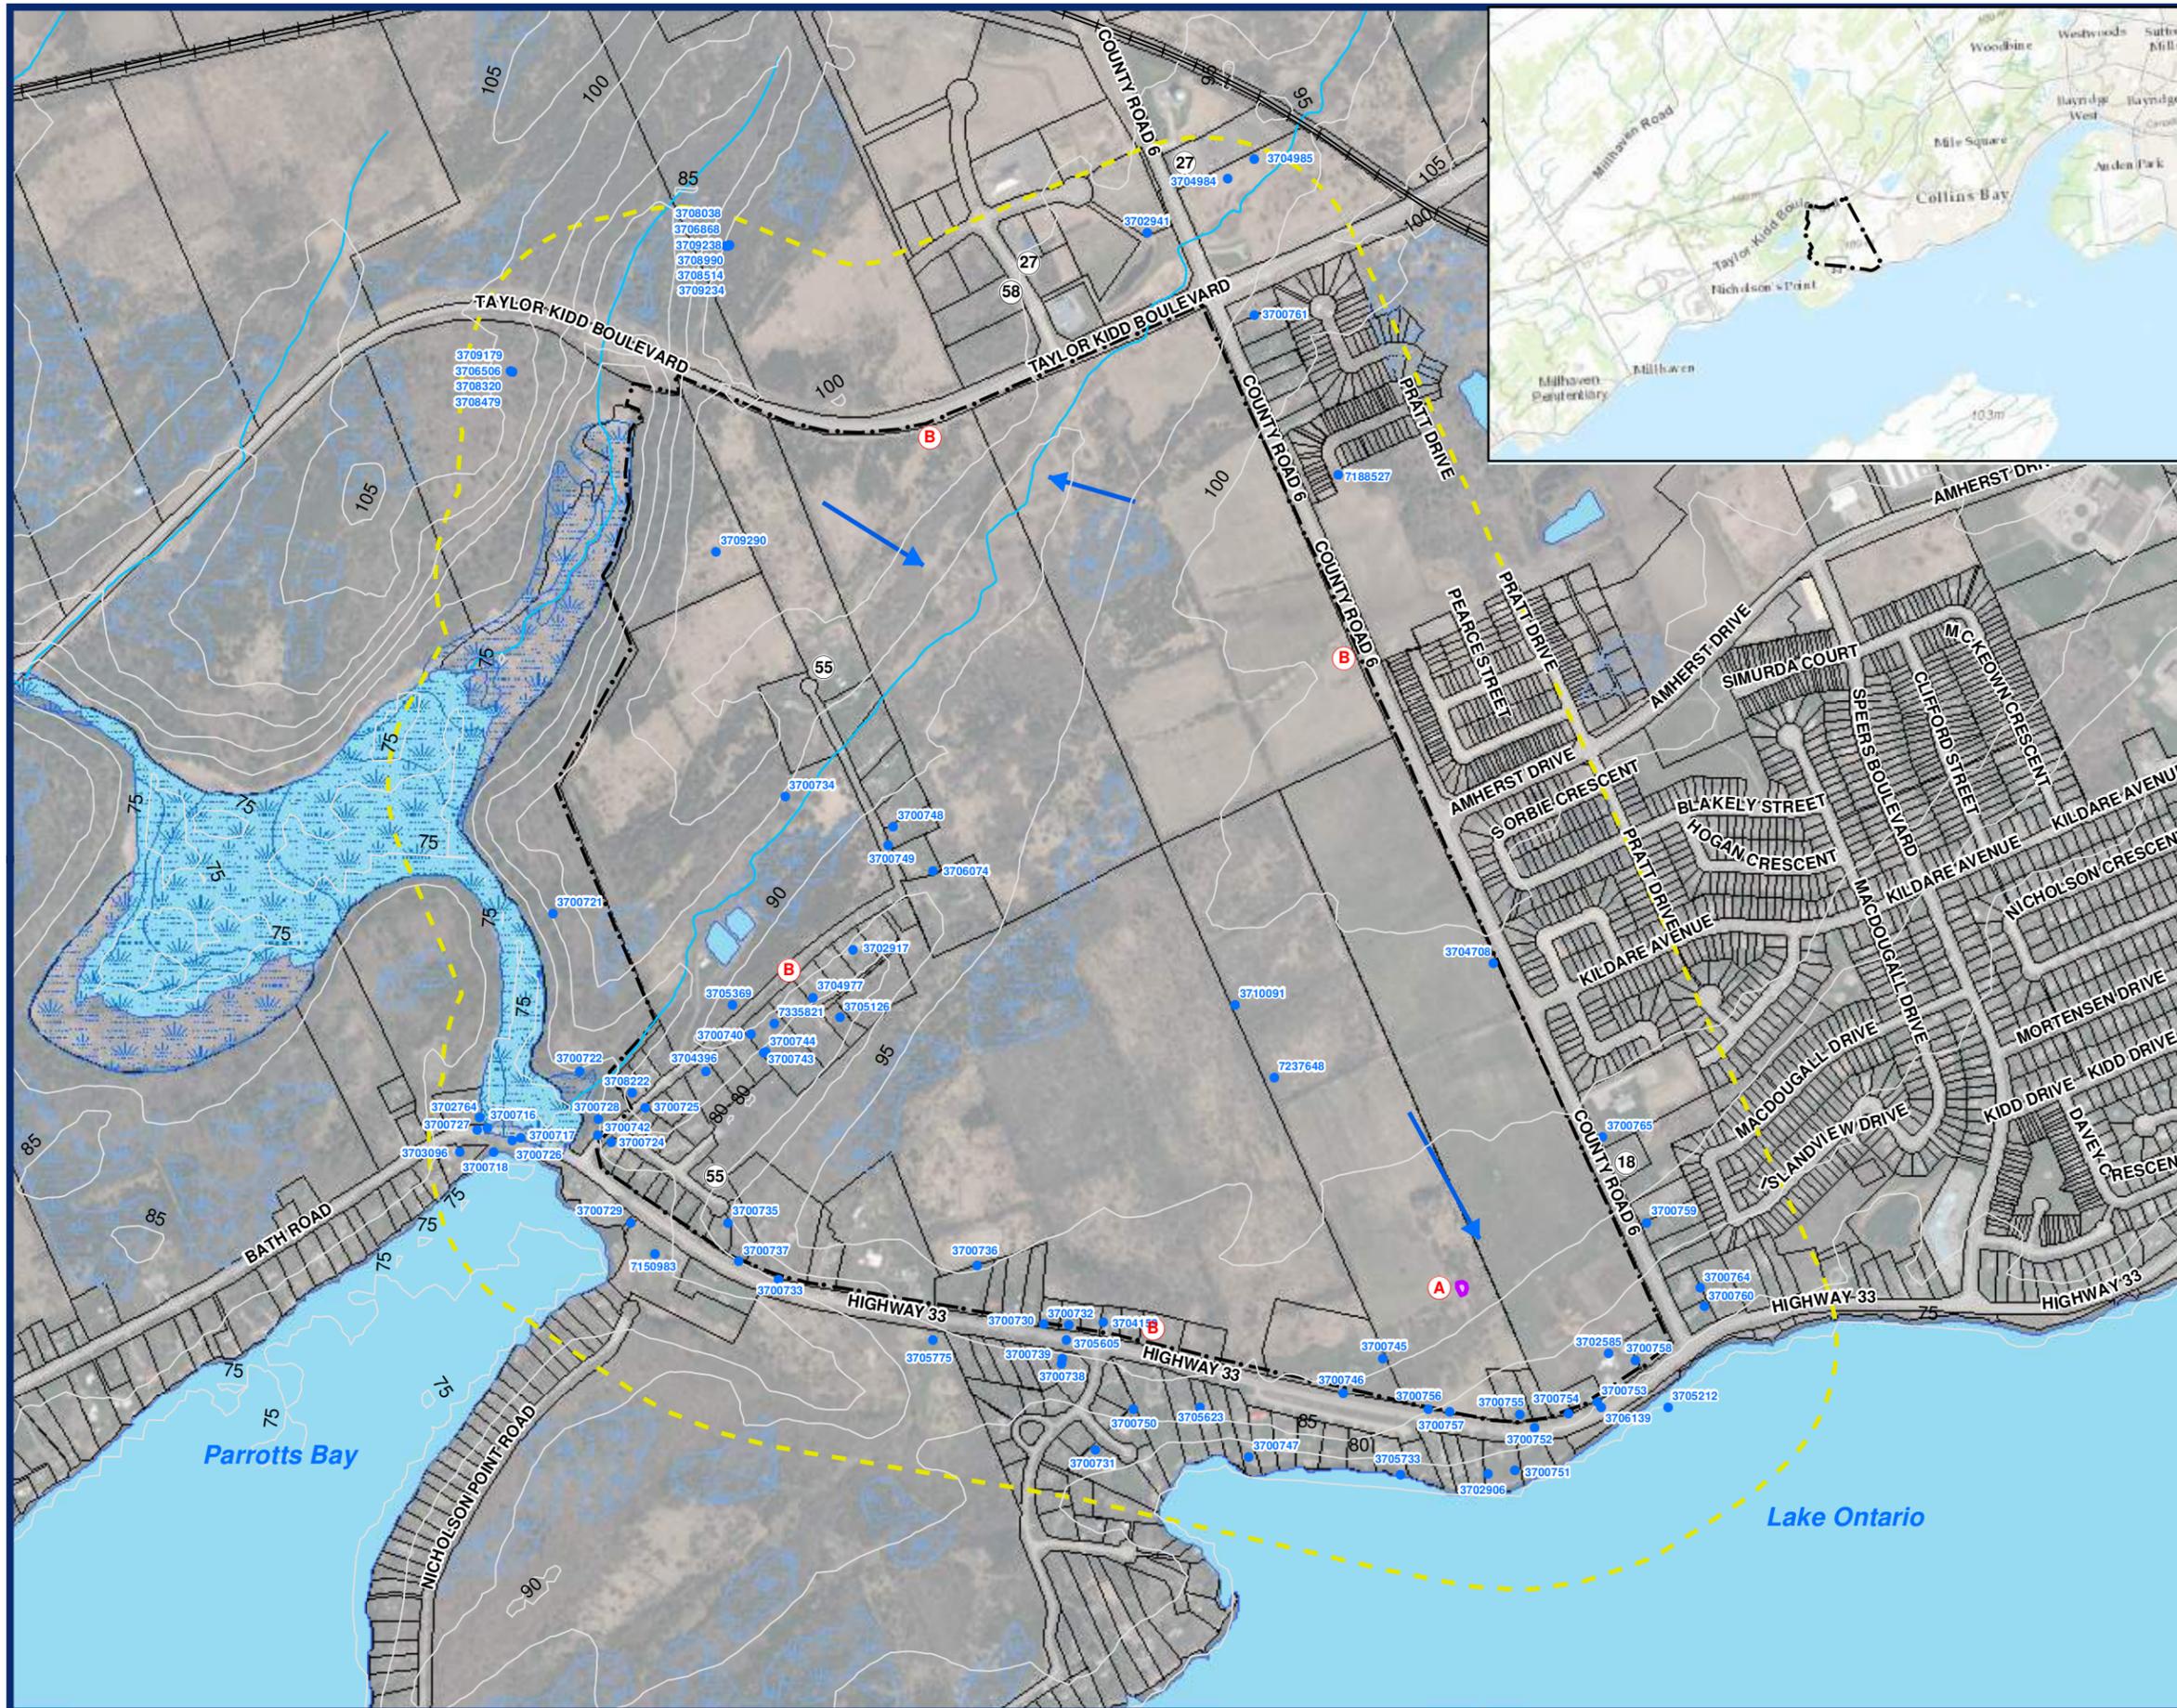
Figure 1
Phase One Conceptual Site Model
Phase One Environmental Site Assessment
Amherstview West Secondary Plan

CRITERION	SPECIFIC OBSERVATIONS
i. Adjacent Land Uses	Adjacent land uses at the time of the Site reconnaissance are illustrated on Figure 1, and were noted as follows: North: Taylor Kidd Boulevard, followed by Commercial businesses South: Bath Road, followed by Residential East: County Road 6, followed by mixed Commercial and Residential West: Parrott’s Bay Conservation Area
ii. Water Bodies	Lake Ontario is located approximately 50 m south of the Site and Parrott’s Bay is located approximately 150 m west of the Site.
iii. Areas of Natural Significance	Parrott’s Bay Conservation Area is located west adjacent to the Site.
iv. Potentially Contaminating Activity	During the site reconnaissance, the following PCAs were identified: <ul style="list-style-type: none"> – Two (2) pole mounted transformers are located on the northwest and southwest portions of the Site; – Brendar Environmental Inc, a waste transfer facility is located approximately 110 m north of the Site; – A small engine repair garage is located approximately 180 m north of the Site; and – Williams Auto Service is located approximately 235 m north of the Site.

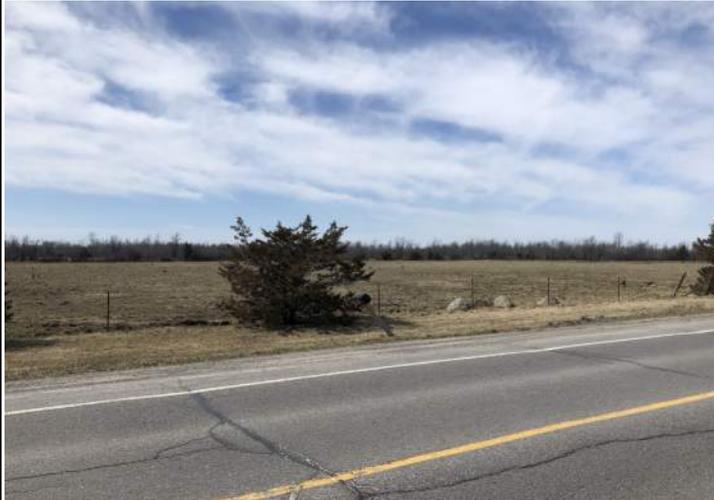
PHOTO 3: Looking north at the agriculture field located in the southeast corner of the Site.

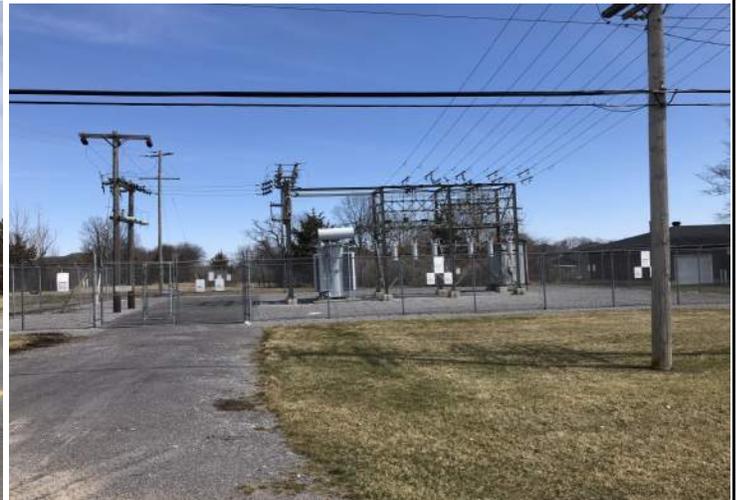
Potentially Contaminating Activity		Description
18	Electricity Generation, Transformation and Power Stations	Phase One Study Area: Based on the interview and site reconnaissance a hydro substation is present east adjacent to the Site on the east side of county road 6. Due to the proximity to the Phase One Property, inferred groundwater flow direction and estimated age of the hydro substation, the substation is not anticipated to contribute to subsurface impacts at the Site.
27	Garages and Maintenance and Repair of Railcars, Marine Vehicles and Aviation Vehicles	Phase One Study Area - Based on the google maps and the site reconnaissance William Auto Service located at 241 County Road 6, approximately 235 m north of the Site operates as an automotive service garage. Based on the site reconnaissance National Small Engines located at 113 William Henderson Drive, approximately 185 m north of the Site, operates as a small engine repair garage. Due to the proximity from the Phase One Property these operation's are not anticipated to contribute to subsurface impacts on the Site.

PHOTO 4: Looking at the hydro substation located east of the Site across County Road 6.

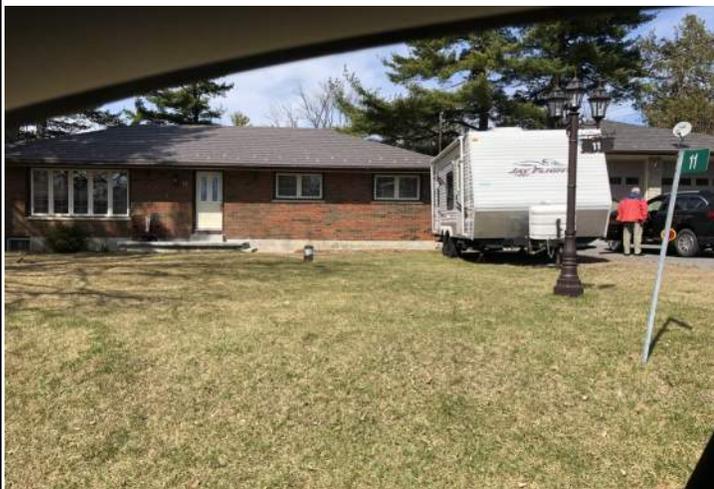
PHOTO 5: Looking at a residence located on Bayview Drive within the southwestern portion of the Site and associated potable water well.

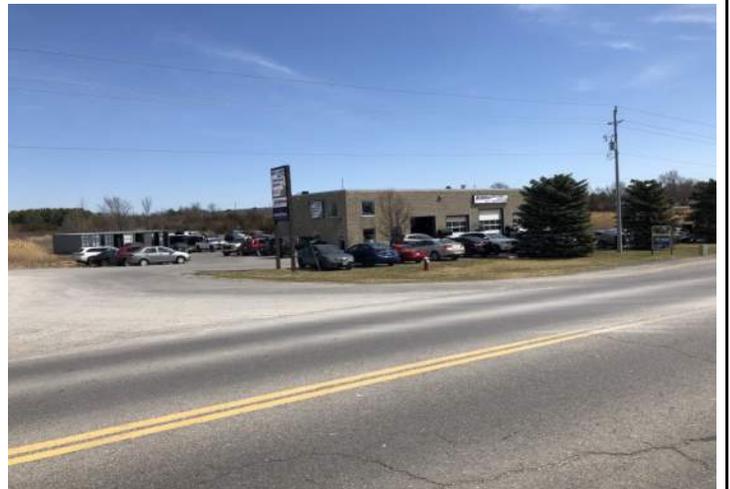
PHOTO 6: Looking southeast at Williams Auto Service located approximately 235 m north of the Site.

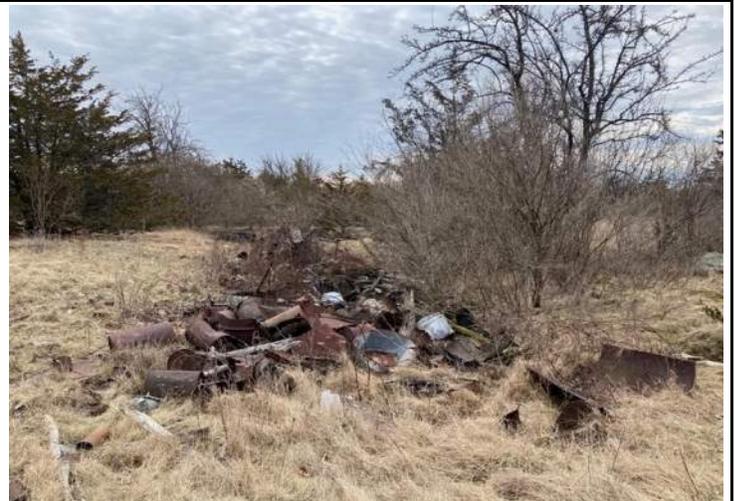
- Due to the agriculture use of the property, pesticides have likely been used across the Site.
- During the site reconnaissance metal drums, and other scrap metal were observed on the southeast portion of the Site. Due to the unknown nature of the materials previously contained within the metal drums, the dumping area requires additional investigation.

IDENTIFIABLE FEATURES	SPECIFIC OBSERVATIONS
iii. Areas Where Fill and Debris Materials Appear to Have Been Placed or Graded	A large pile of scrap metal and metal drums with unknown contents was observed on the southeastern portion of the Site. The location of this debris is shown on Figure 1 and Figure 2.
iv. Potentially Contaminating Activity	A large pile of scrap metal and metals drums with unknown contents was observed on the southeastern portion of the Site. The location of this debris is shown on Figure 1 and Figure 2.
v. Details of Unidentified Substances Found at the Property	There were no unidentified substances observed outside the building at the Phase One Property.

A	Dumping Activities	Phase One Study Area: Based on the site reconnaissance metals drums, and other scrap metal were observed on the southeast portion of the Site. Due to the unknown nature of the materials previously contained within the metal drums the dumping area is considered an APEC on the Site (APEC 1).
B	Seasonal De-Icing Activities	Phase One Property: The Site is located adjacent to multiple heavily trafficked roadways and as such seasonal de-icing activities occur for vehicle and pedestrian safety. The seasonal de-icing activities contribute to an APEC on the Phase One Property (APEC 2).

PHOTO 8: Looking at the large scrap metal part and metal drum pile located on southeast portion of the Site.

Based on the findings of the Phase One ESA, current and historical PCAs which could adversely affect environmental condition of the Site were identified; therefore, it is recommended that a Phase Two ESA be undertaken to characterize soil and ground water quality.
